Manhole Inspection Summary

Manhole # S130__024MH

Insp Date: **3/25/08 9:30 AM**

Location Address: **361 Font Hill**

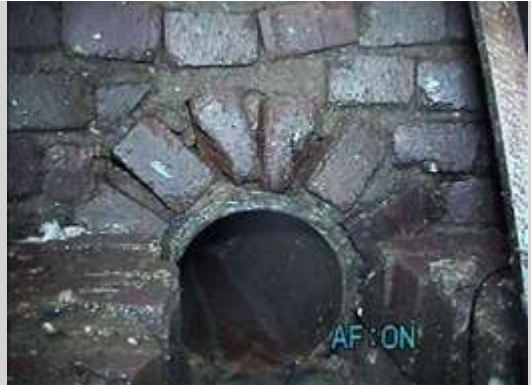
12 O'Clock Outflow

8 in. Circular Gravity Sewer
Pipe Out @ 12 O'Clock

Pipe Height: **8.4** (in.) Rod and Bar (Angled)
Pipe Material: **Clay** ☐ Pipe Lined
Invert Depth: **11.00** (ft.) Flow Characteristics: **Slow**
Deposits: ☒ None ☐ Mud ☐ Sludge ☐ Debris ☐ Grease
Silt Depth: **0** (in.) Deposits Extent:
Infiltration: **None** Pipe Seal Cond: **Sound**

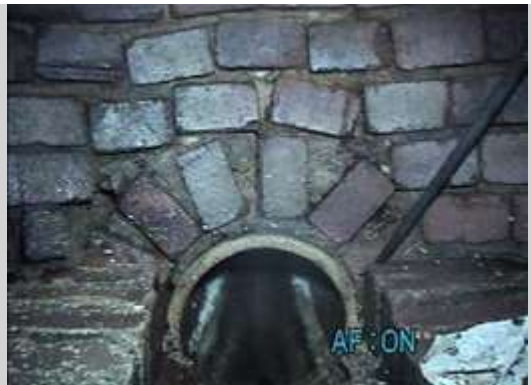
6 O'Clock Inflow

8 in. Circular Gravity Sewer
Pipe In @ 6 O'Clock

Pipe Height: **8.4** (in.) Rod and Bar (Angled)
Pipe Material: **Clay** ☐ Pipe Lined
Invert Depth: **10.44** (ft.) Flow Characteristics: **Slow**
Deposits: ☒ None ☐ Mud ☐ Sludge ☐ Debris ☐ Grease
Silt Depth: **0** (in.) Deposits Extent:
Infiltration: **None** Pipe Seal Cond: **Sound**

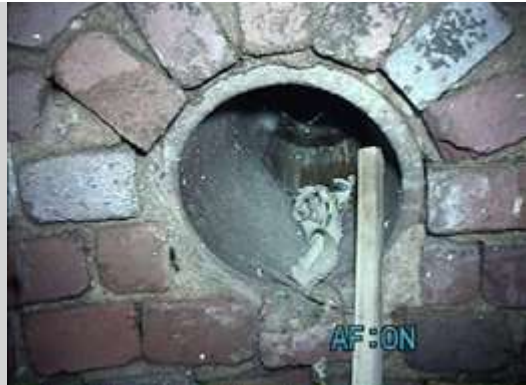
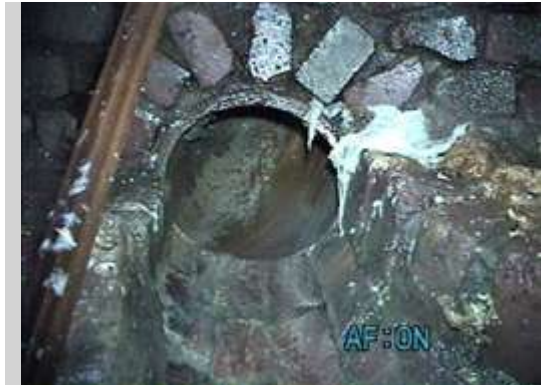
9 O'Clock Inflow

8 in. Circular Gravity Sewer

Pipe In @ 9 O'Clock

Drop In @ 9 O'Clock

Pipe Height: **8.4** (in.) Rod and Bar (Angled)
